## 4 Structure

### 4.1 Description

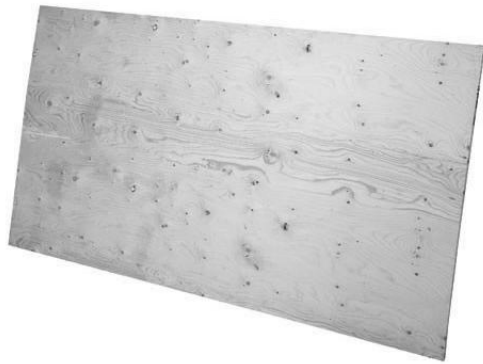
Fig. 4.14 Sub-floor materials

Plywood (4'x8' panel)

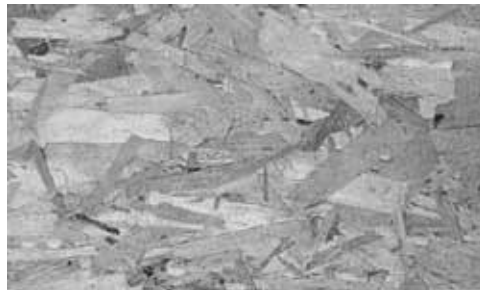
OSB (Oriented Strand Board) (4'x8' panel)
